ENVIRONMENT CANADA
CONSERVATION AND PROTECTION
ENVIRONMENTAL PROTECTION SERVICE
PACIFIC AND YUKON REGION

COMPLIANCE ASSESSMENT REPORT ON WOOD PROTECTION (ANTI-SAPSTAIN) FACILITIES IN BRITISH COLUMBIA (1984)

Regional Program Report 86-08

JUNE 1986

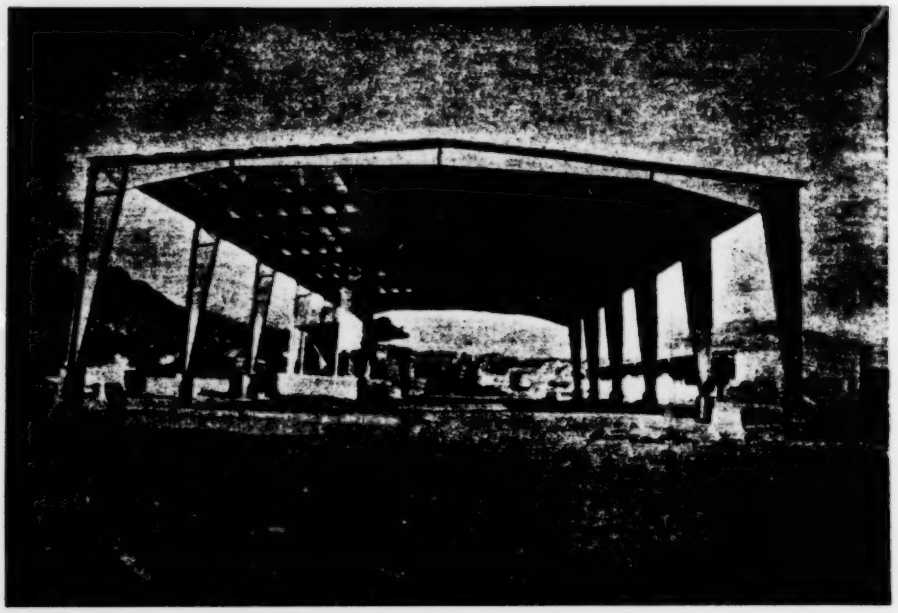
FIGURE 2 EXAMPLES OF COVERED STORAGE OF ANTI-SAPSTAIN TREATED LUMBER

Table 2 indicates that only 8% of sawmills and lumber export terminals have covered final storage of treated lumber. As noted earlier, uncovered lumber storage is suspected as a source of low-level releases of chlorophenates into the environment. However, the cost of providing covered storage can be high and this recommendation remains a controversial topic with the forest products industry. EPS and the B.C. Ministry of Environment will undertake a study in 1986 to better define stormwater contamination at selected mills. Releases of chlorophenates in stormwater will be compared at selected dip and spray facilities with and without covered storage of lumber.
